HO-329, Howard Lodge No. 101 Masonic Building
5814 Main St., Elkridge
Surveyed by: Kristin Hill
April 2003

INVENTORY FORM FOR STATE HISTORIC SITES SURVEY

The Howard Lodge # 101
Masonic Building

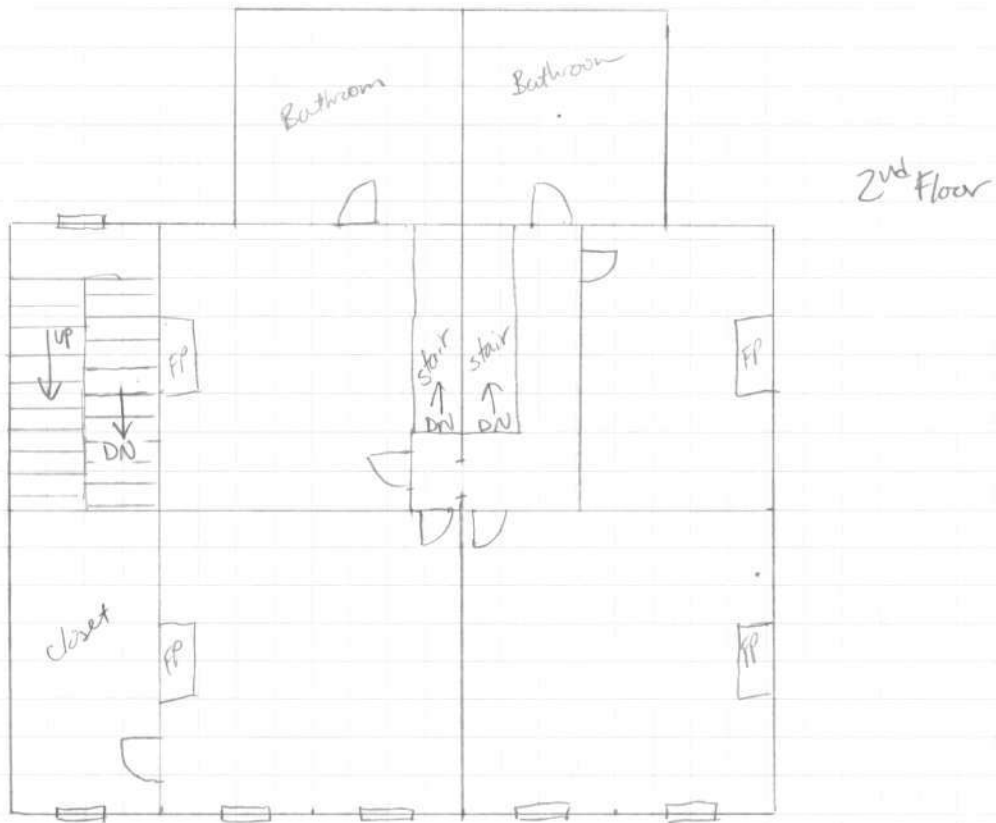
H0-329
Howard Lodge Masonic Building
5814 Main St., Elkridge
Howard County
Drawn 4/03, by Kristin Hill

doors have
hole w/ speaking
tubes on exterior

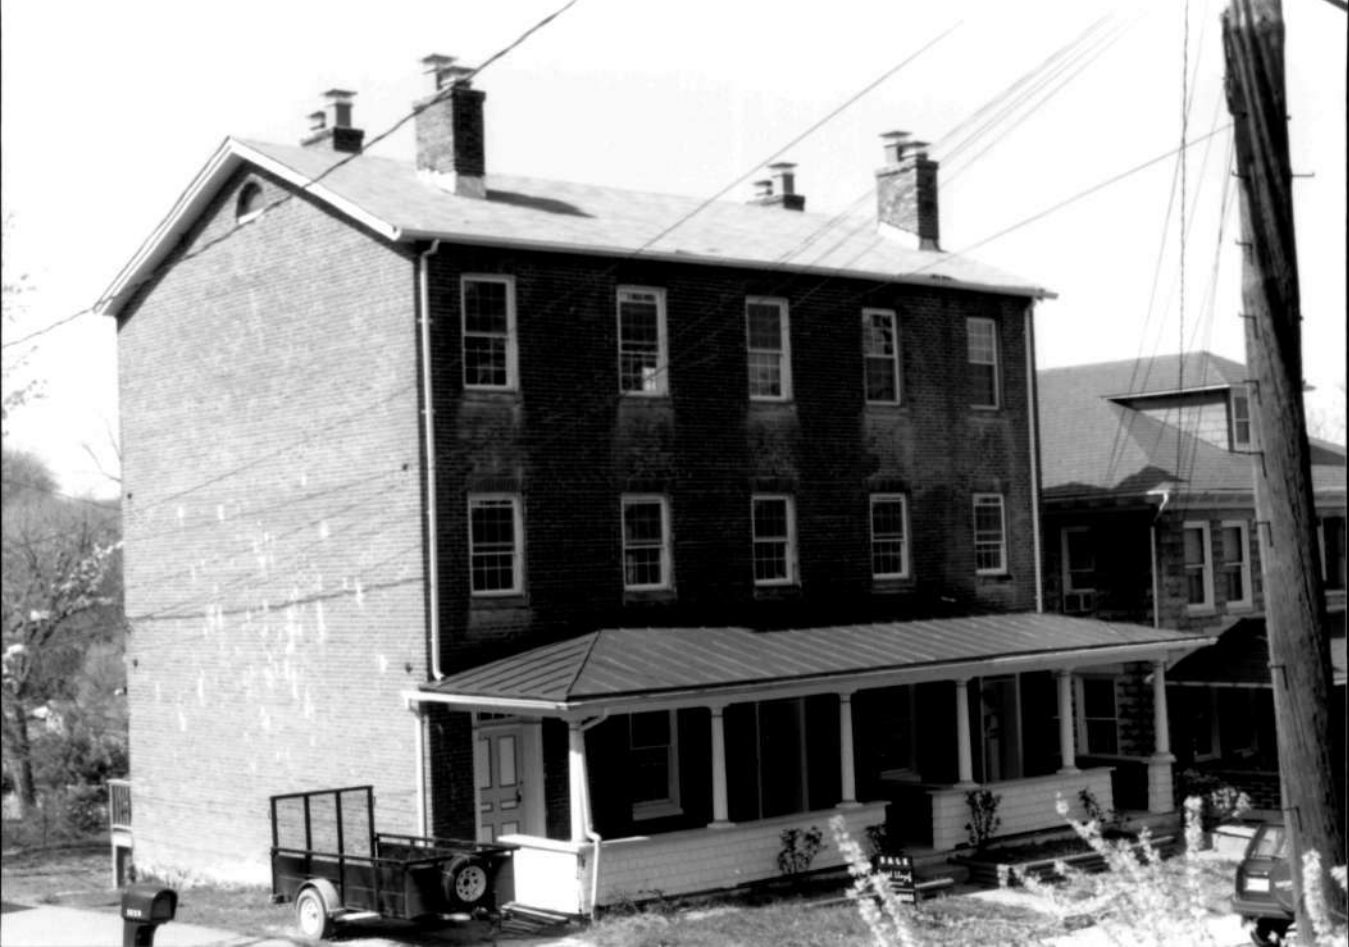
1 of 11

Negative at MD SHPO
Southwest elevation

This fascinating building faces south on the north side of Main Street and is the third building west of the intersection with Brumbaugh Street. The three story, five bay, double pile brick building is built of 5:1 common bond and rests on a stone foundation. A low pitched side gabled roof is pierced by four massive interior brick chimneys. Both the front and rear facades have matching corbelled brick cornices and jack arches over all window and door openings. The building is in the process of being renovated and is currently for sale. As a part of this renovation, all of the original windows were unfortunately removed and replaced with vinyl units with snap in muntins but the sizes of the window openings were not altered. Three entrances are located on the first floor of the front façade, one in the central bay and one in each end bay. The door in the west end bay may be an original paneled door with a four light transom. This door leads into a narrow hall which contains the original stair running up to the third floor Masonic/ Temperance Hall. The doors in the central bay and the other end bay are glazed and paneled and not original. Both have transoms and while the existing windows are not original, both the door and transom openings are original. The second and third floor windows are vertically aligned above the first floor openings and it is unusual that the third floor window openings are larger (and were originally so) than the second floor openings. A single story full width hipped roof front porch is not original to the building and confuses the simplicity of the façade. The porch currently has a solid balustrade

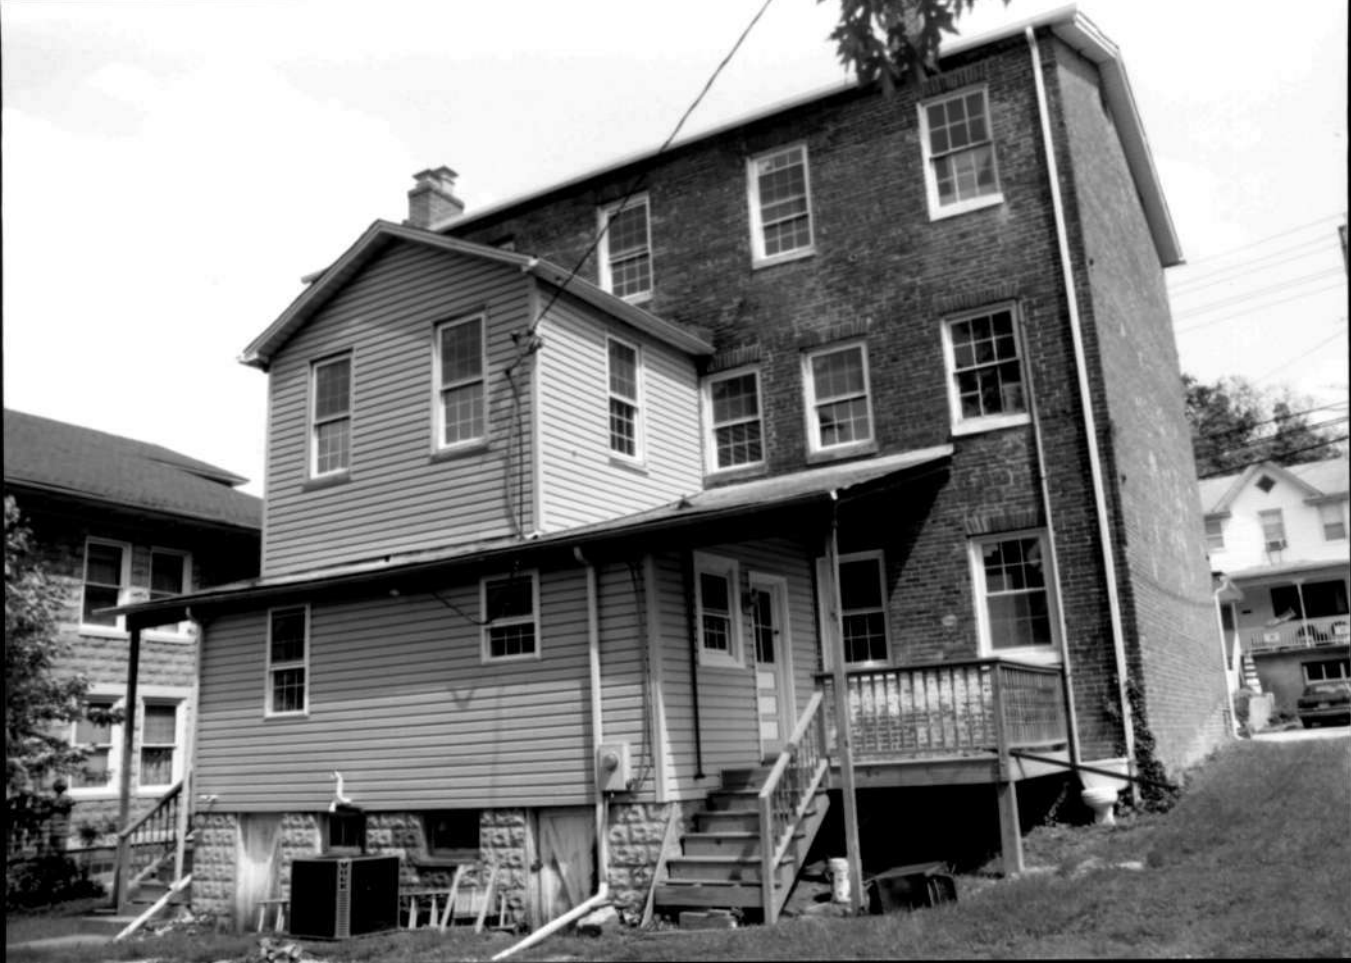
2 of 11

North (near) elevation

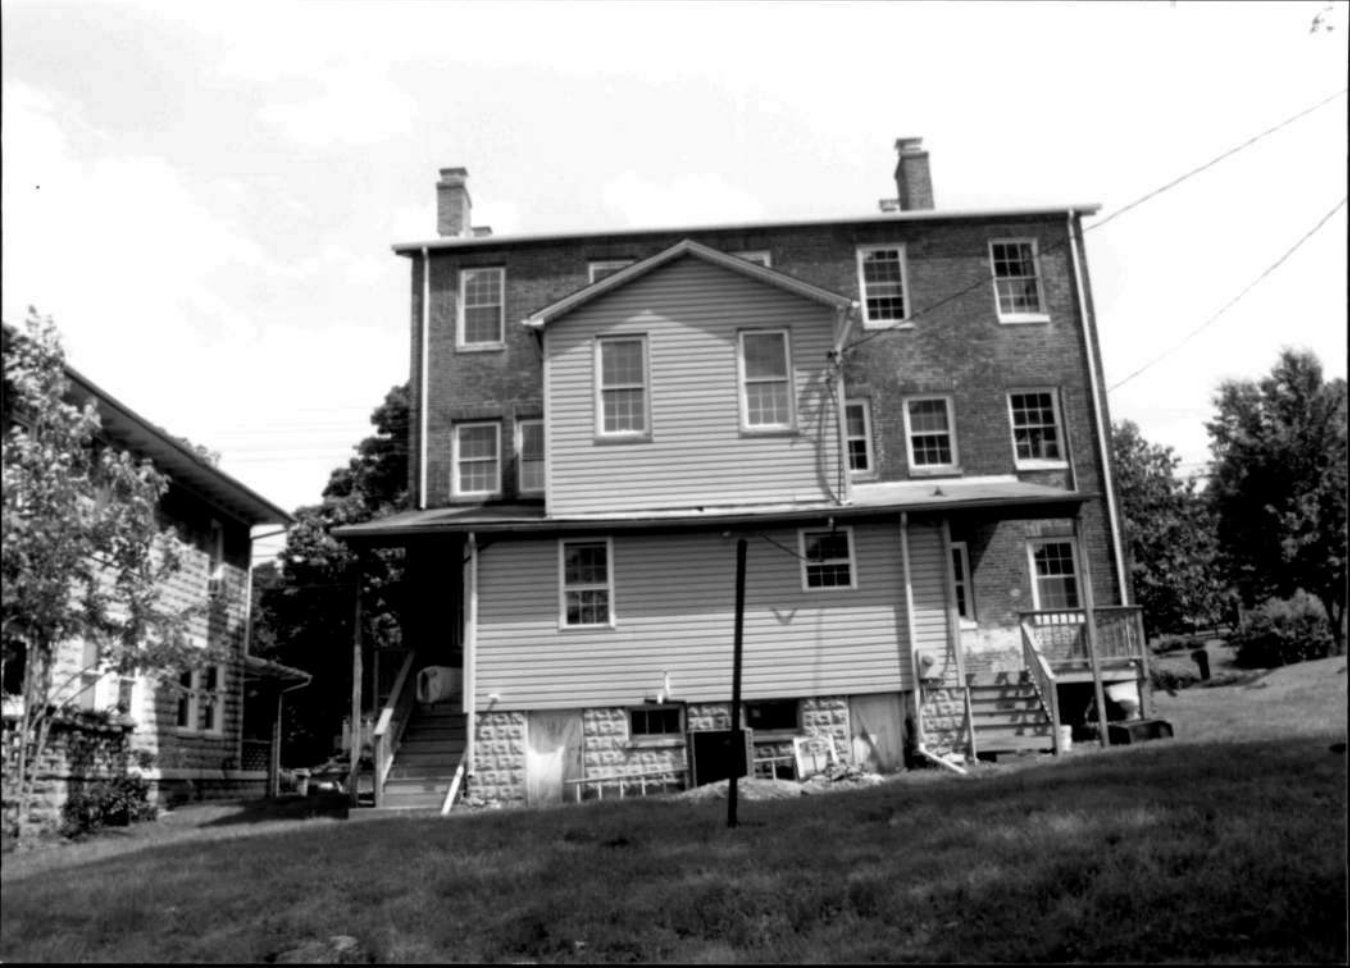
3 of 11

North (rear) elevation

The rear façade of the building probably originally closely mirrored the front façade but sometime in the early 20th century a two story two bay frame addition was made. The addition projects from what is approximately the middle of the eastern-most two thirds of the building and rests on a rusticated concrete block foundation which contains a substantial crawl space. There are two windows and two batten doors located in the north façade of the rusticated concrete block foundation. The fenestration of the rear façade of the brick part of the building was altered to accommodate the frame addition as both window openings and their accompanying jack arches were shifted to either side.

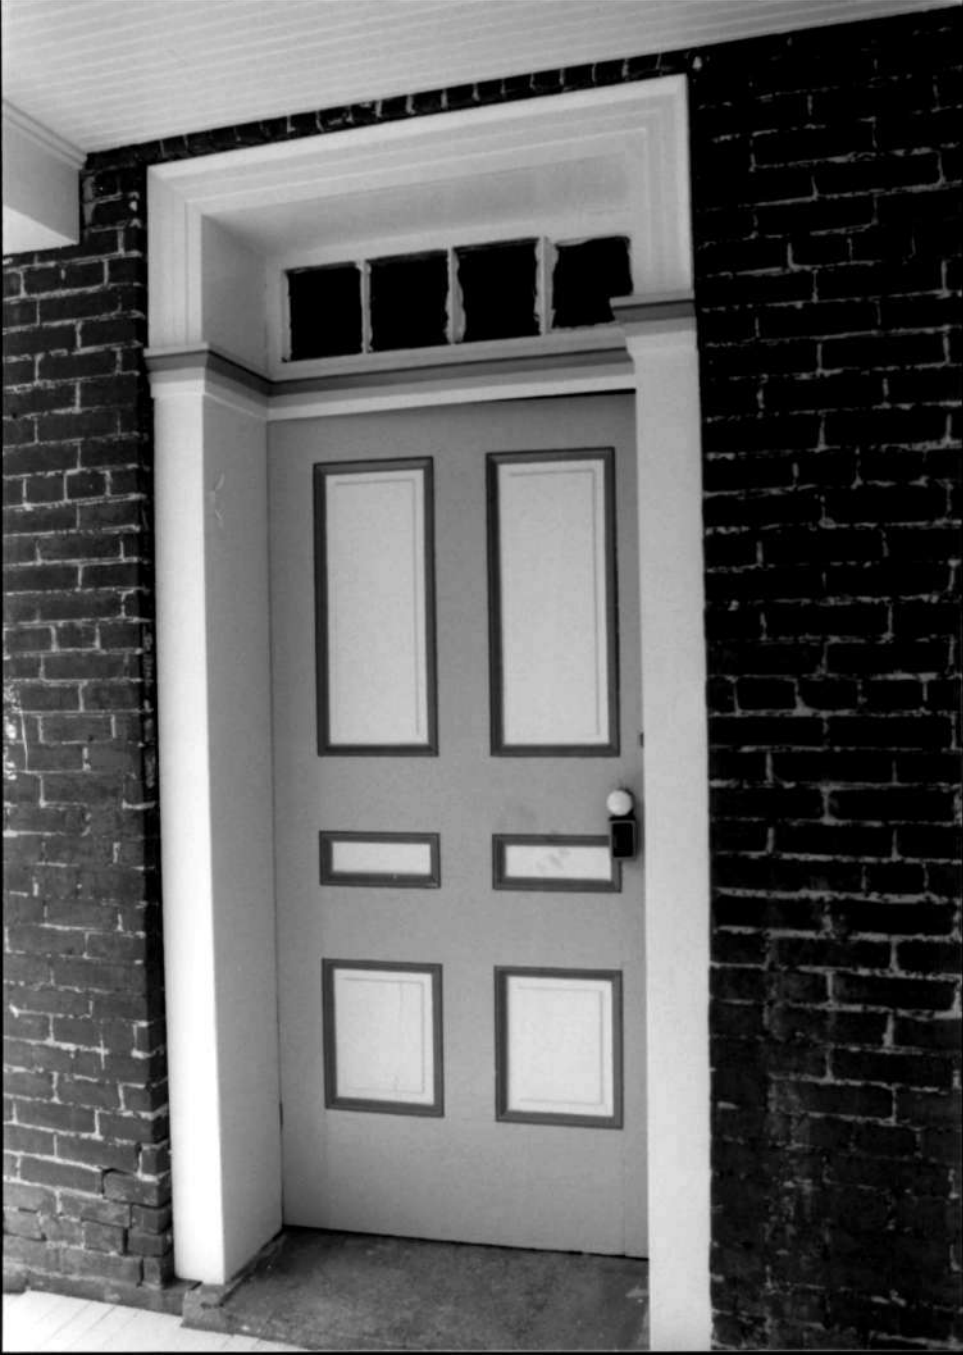
4 of 11

West-most front door.

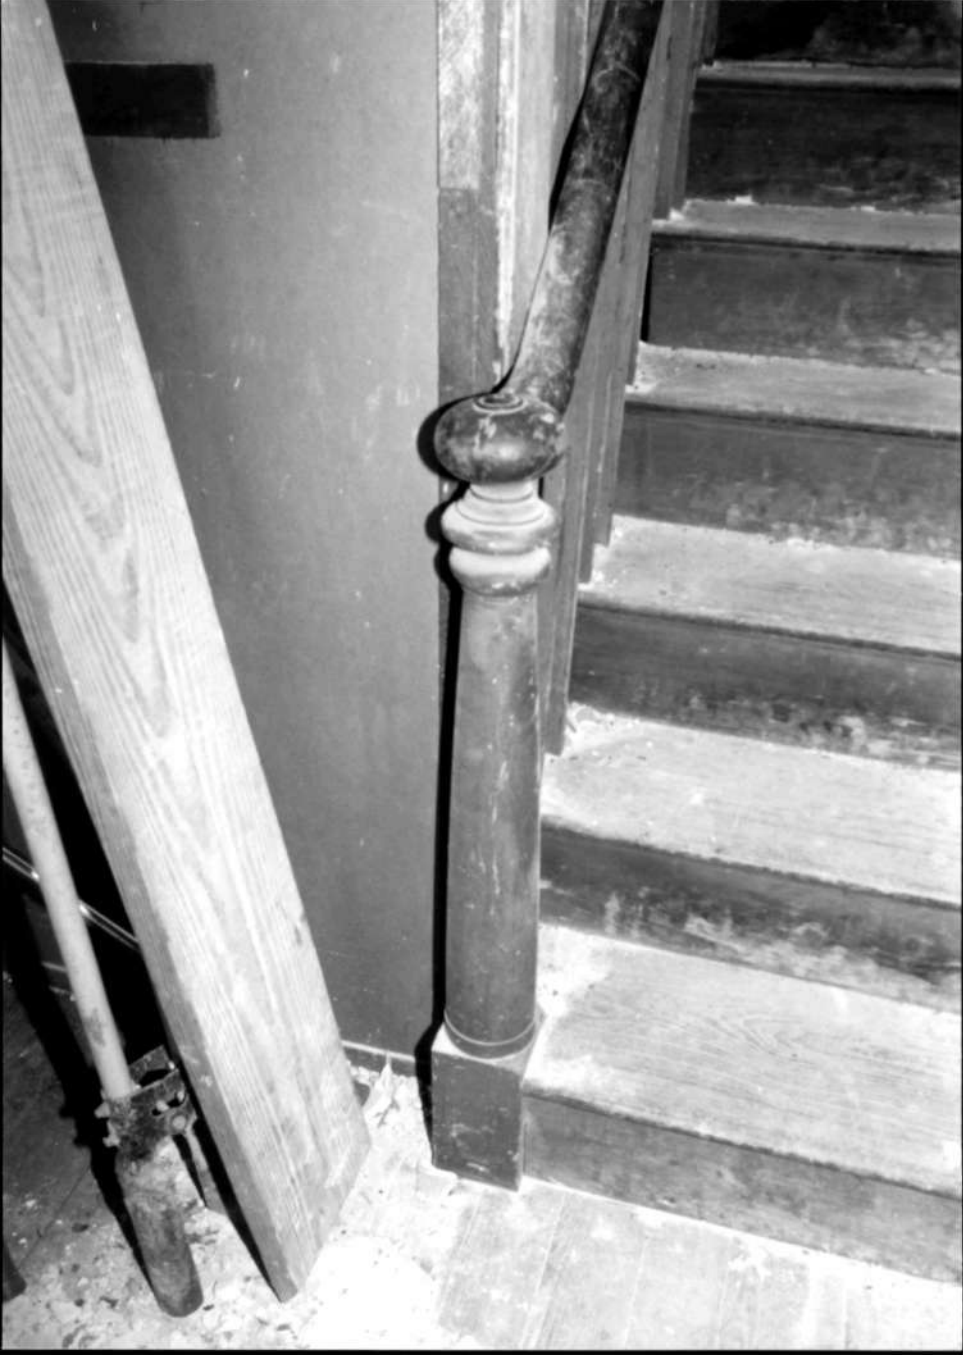
5 of 11

Nevel post on 1st floor of stair to 3rd floor hall.

The stair to the third floor is located in the west bay of the building and is an excellent example of an early Greek Revival stair with a graceful turned newel post and ramped handrail. The balusters are square and arranged two to a tread. The open stringer has no stair end decoration. A closet, accessed from the rear room of the middle dwelling

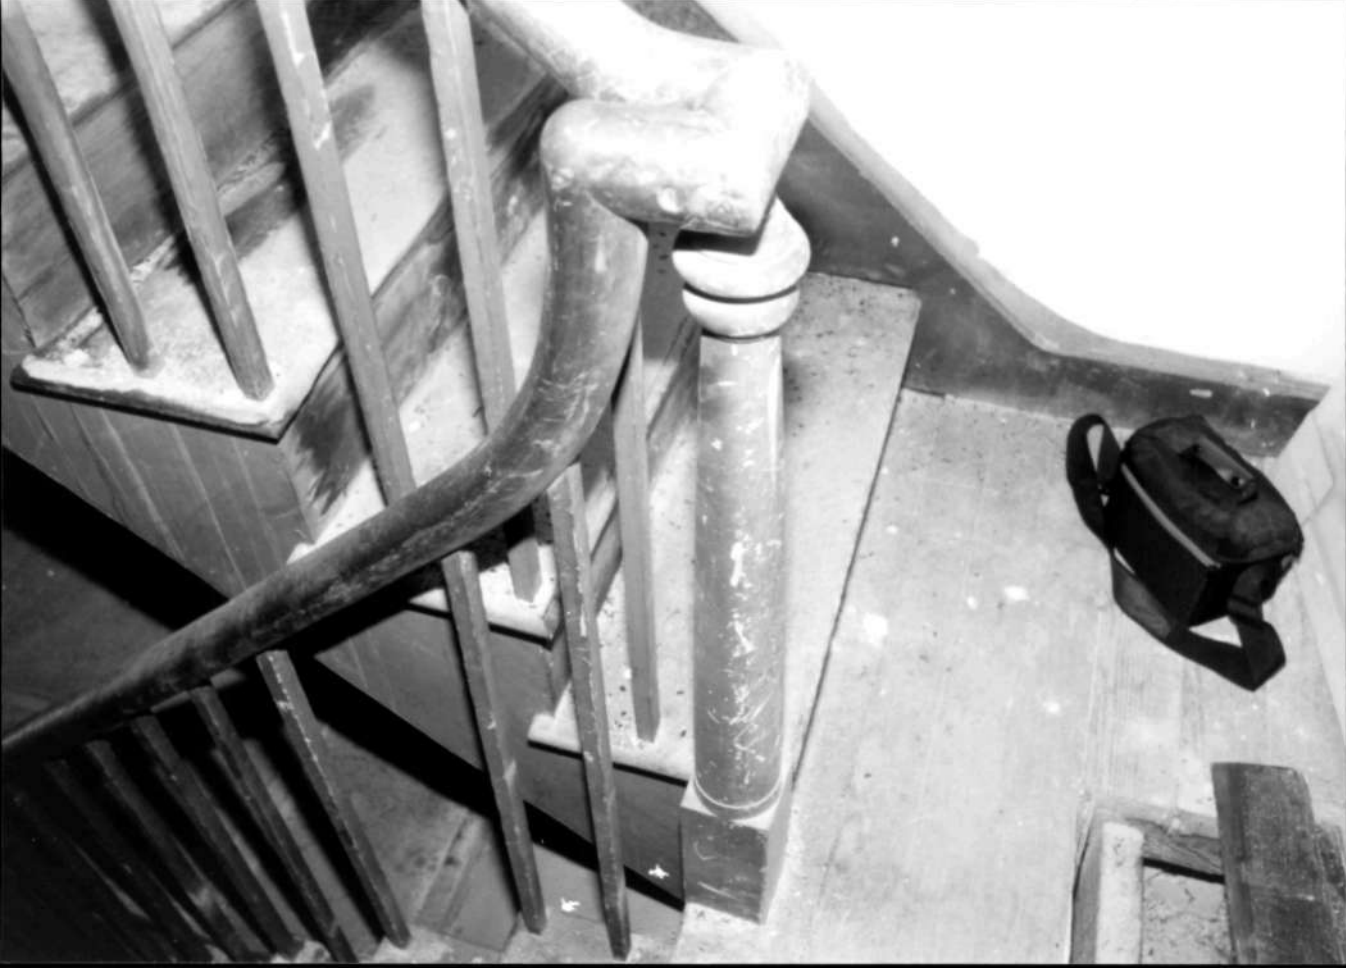
6 of 11

Newel post and ramped handrail at 2nd floor landing
of stair to the 3rd floor hall.

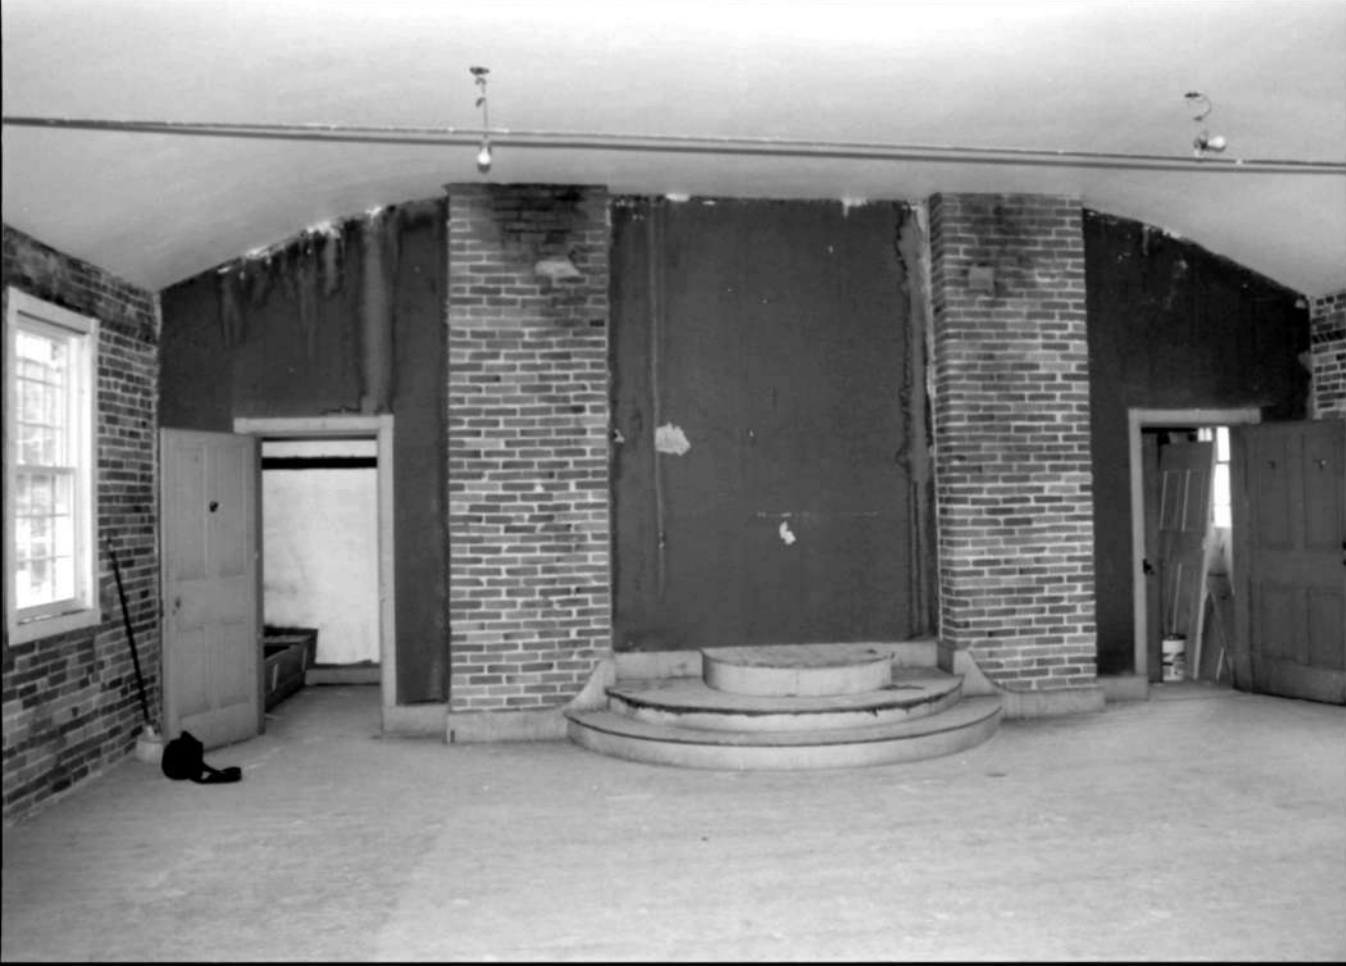
7 of 11

West end of 3rd floor hall/meeting space.

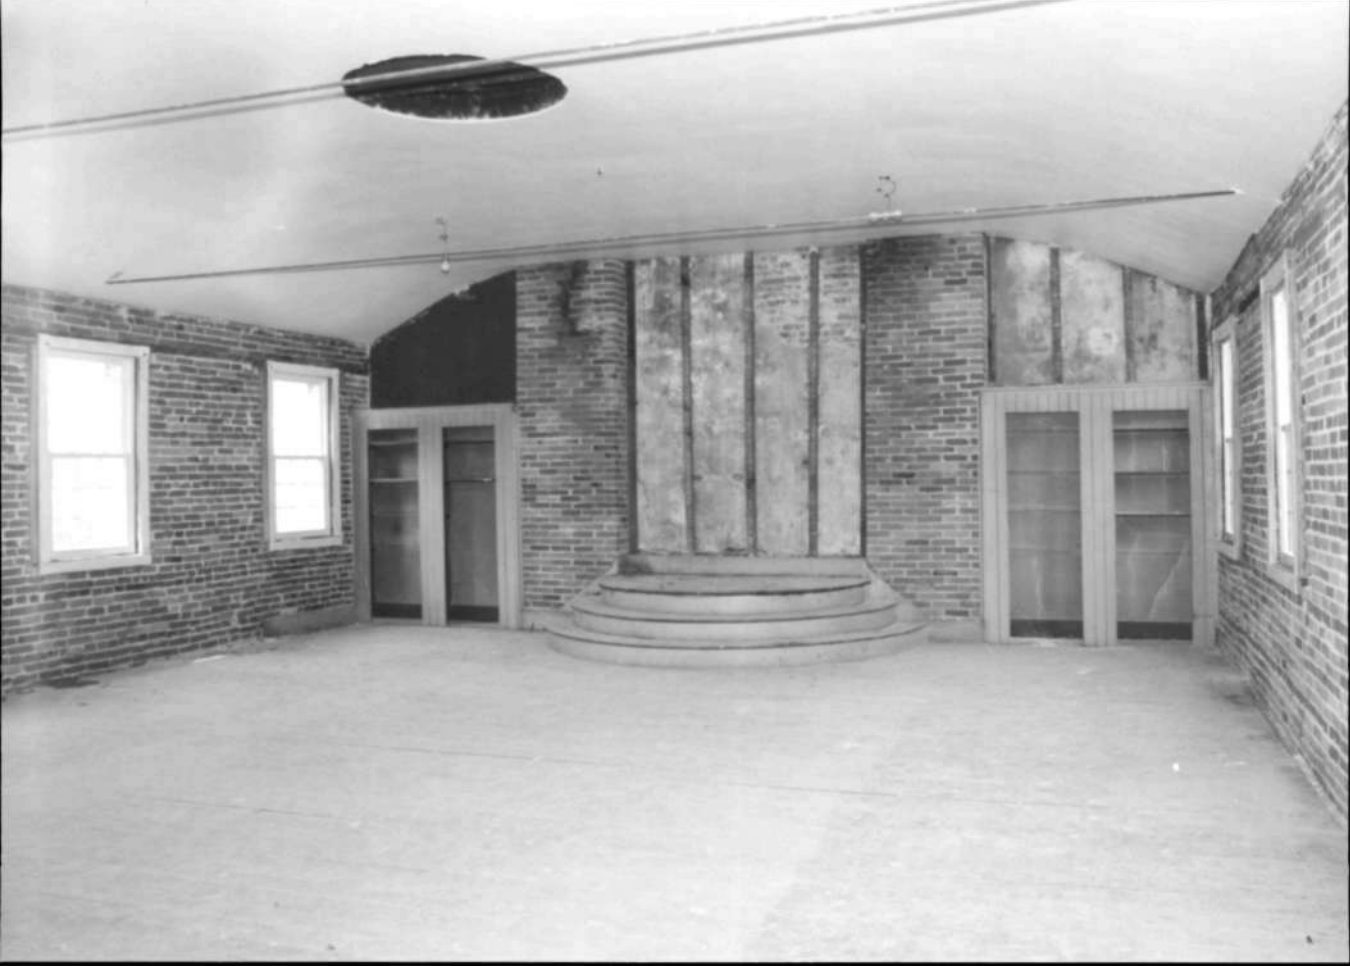
8 of 11

East end of 3rd floor hall/meeting space.

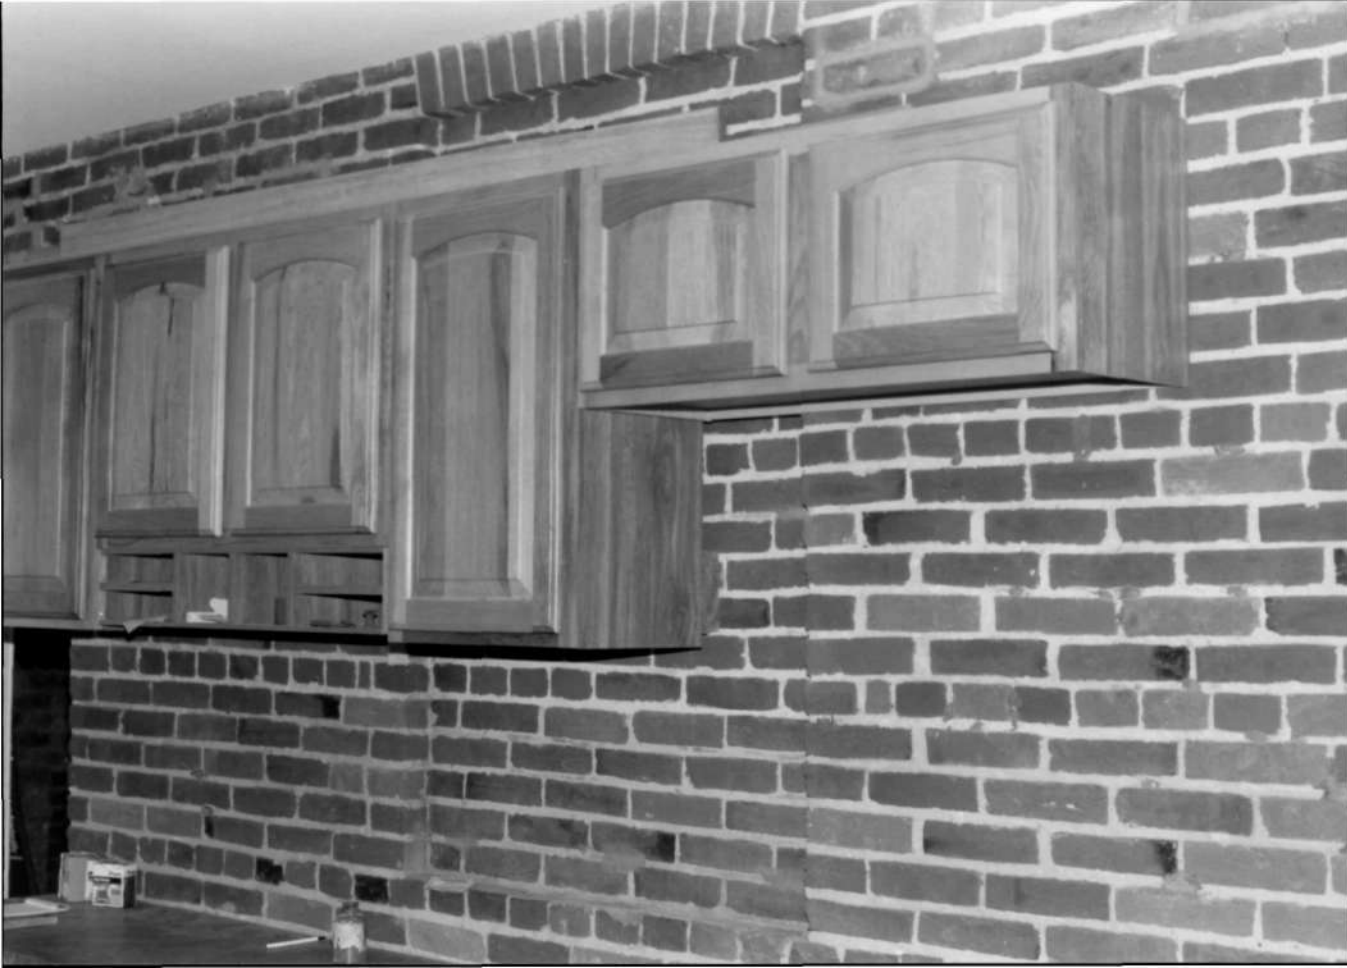
9 of 11

Closed window w/ jack arch on original rear exterior
wall.

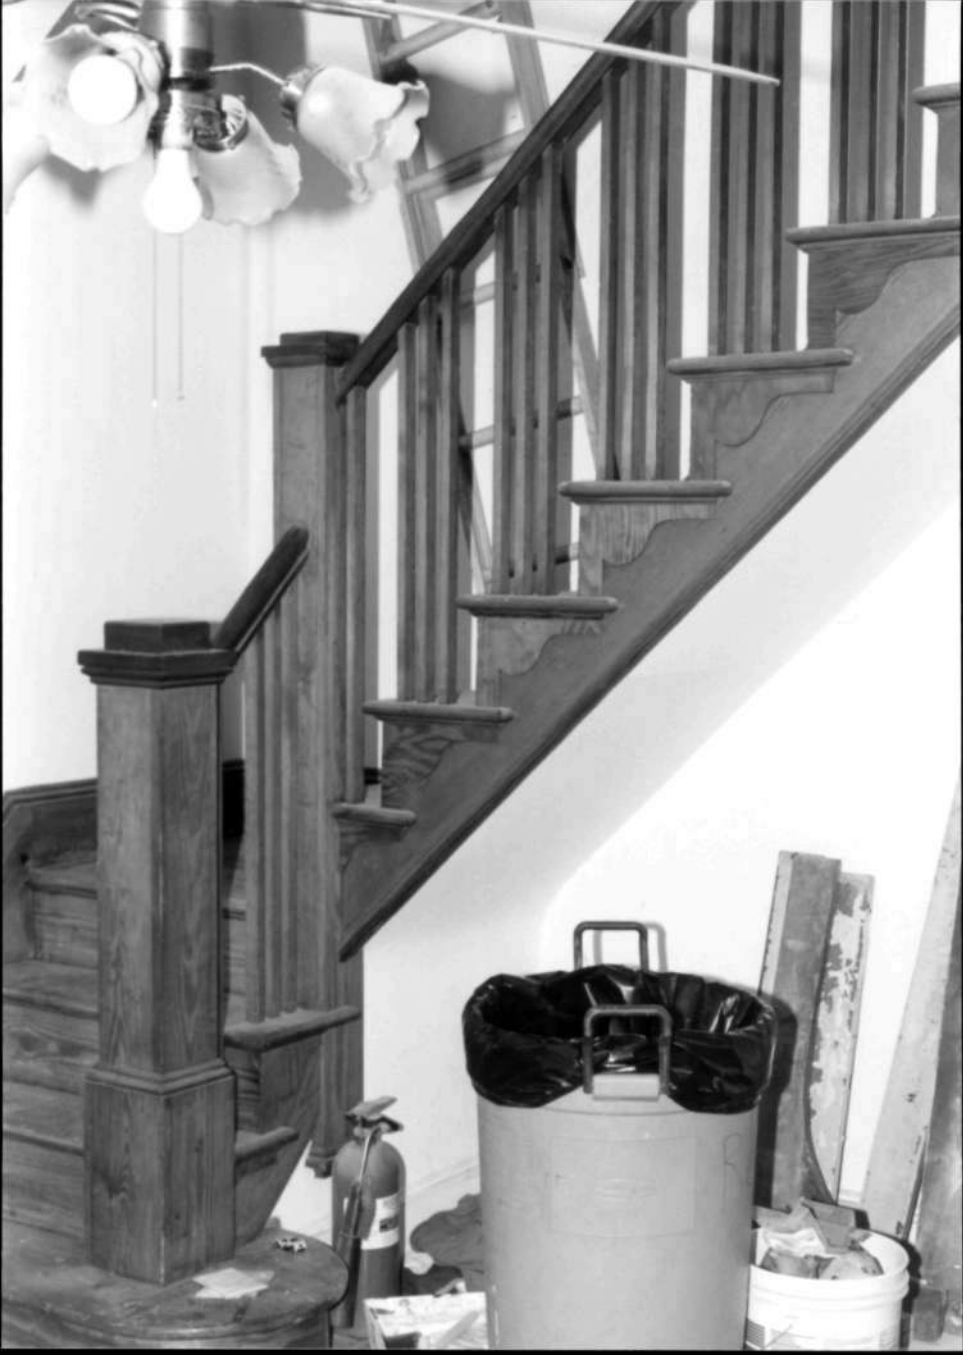
10 of 11

Stair in the center dwelling unit.

stair in the middle unit does have scroll decoration on the stair ends that may be original, and there is no reason to believe that the staircases themselves are not original. The other stair in the east end unit is currently lacking a balustrade and newel post, but the back of the stair has been opened up during the current renovation revealing that the boards are all sash sawn and the stair is constructed with machine headed cut nails.

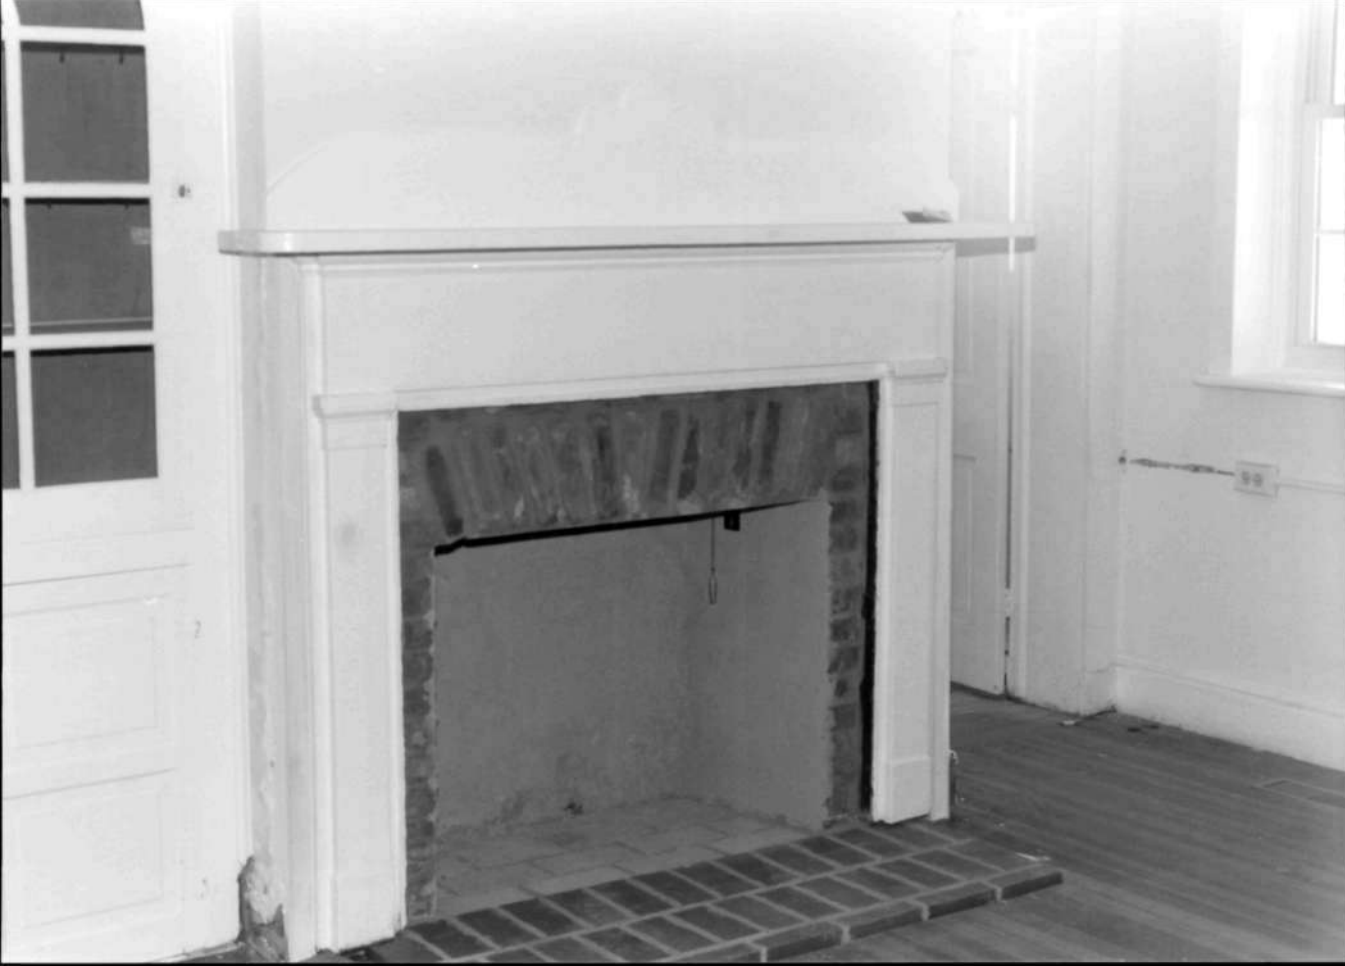
only remaining original mantle with pieces added
to the top and sides.

One original mantle remains in the house, though it has been altered during the current renovation. It is located in the first floor rear room in the middle unit and is a classic, simple Greek Revival wood mantle with bottom corner plinths, flat pilasters and frieze, and molded cornice. During the current renovation, reeded boards were added on either side of the original pilasters and a curved over mantle was added above the mantle shelf.
